Article 1283 - Momentary Engine Hesitation on Acceleration and/or Rough Engine Idle

TSB #85 - February 9, 1968

(1968 390-4V GT Engine Equipped Vehicles [Holley Carburetor] Built Prior to Approximately December 15, 1967)

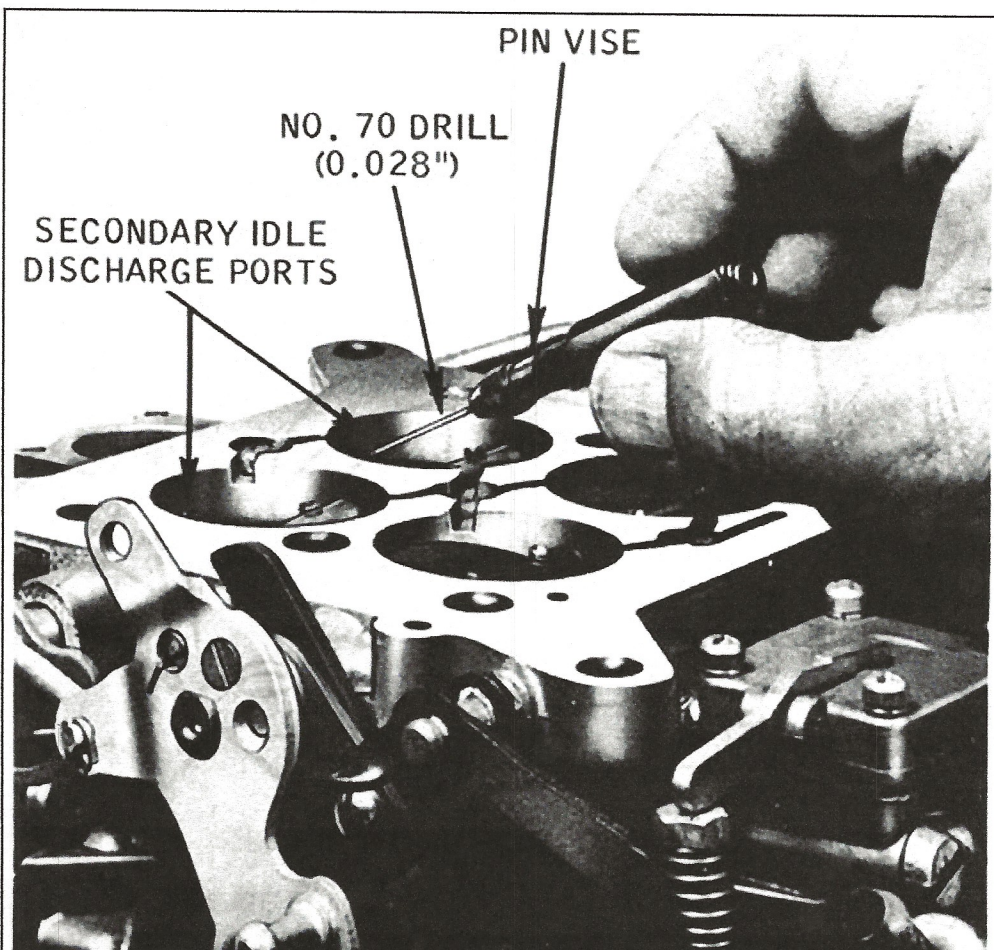
*Figure 5 — Secondary Idle Discharge Ports Enlargement —
Holley 4 - V Carburetor (Article 1283)*

Complaints of this condition are primarily caused by a lean carburetor fuel condition at idle and off idle engine speeds. Subject units produced after the December 15, 1967 corrective date are equipped with a revised carburetor to eliminate possible occurrence of this problem. The revised carburetor can be identified by a white paint daub on the identification tag.

1. Secondary Idle Discharge Port — Remove the carburetor from the engine and use a No. 70 drill (0.028 inch) in a pin vise to very carefully enlarge the two idle discharge ports in the secondary throttle bases. Refer to Fig. 5.

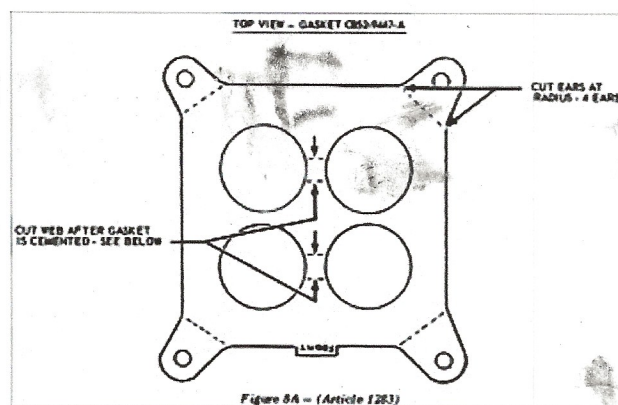
Fig. 8A

- **Base Over 0.015 Inch Out of Flat**

- Remove the ears from a C8SZ-9447-A carburetor base gasket as shown in Fig. 8A.
- Cement a C80Z-9447-A carburetor base gasket (brass grommets in the mounting stud holes) to the top of the gasket modified in Step "a" using gasket cement. Be sure the four (4) gasket venturi holes are perfectly aligned.
- After the gaskets are cemented, cut the center webs between the right and left venturi from the gasket previously modified (Fig. 8A) to make the two (2) gaskets similar in that area.
- Reinstall the carburetor using this cemented gasket combination. Install this gasket as shown in Fig. 8B. Torque the carburetor attaching bolts alternately to 6-8 ft.-lbs. and then alternately increase this torque to a final 12—15 ft.-lbs. specification.
